**Southwest Research Institute (SwRI) Project
18.03562
"Evaluation of Tungsten Alloy Rods"
Final Report**

Kathryn Dannemann and James Walker

May 2000

IAT.R 0301

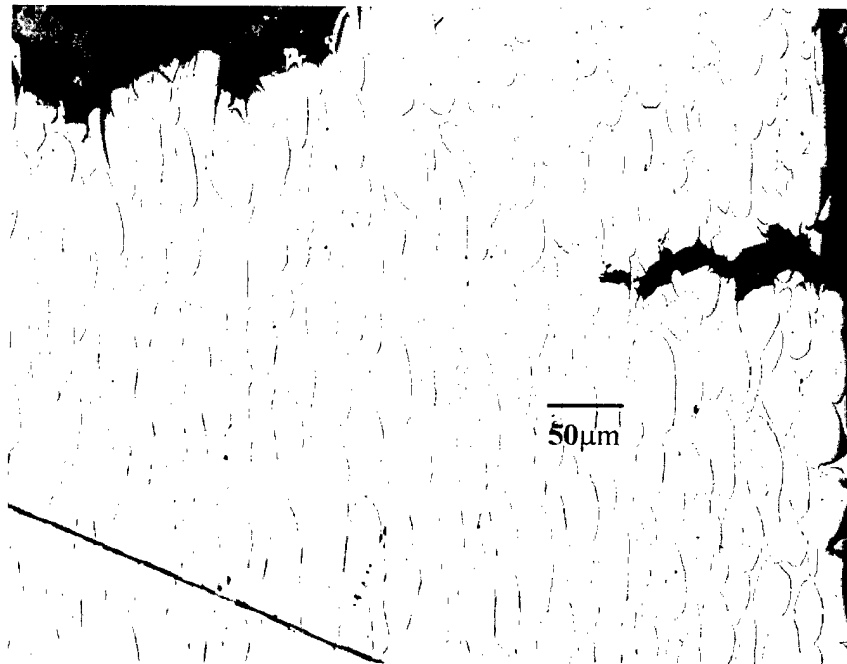
Higher magnification microscopy of the mounted cross-sections revealed the tensile cracks progressed through some of the W particles, resulting in cleavage of the particles. Fracture of the W particles is evident in representative photos of the tensile cracks, illustrated in Figure 2. The cracks also progressed along W particle/matrix interfaces. Some W particle fractures were observed on the compressive side of the samples near the initial bend region. A limited number of isolated W particle fractures and W particle/matrix fractures were detected towards the center of the sample cross section. Some fractured W particles were observed along the fracture surface on both the tensile and compressive sides of the samples evaluated. Particle fractures were more prevalent on the tensile fracture surface. Some W particle-particle decohesion was detected for W particles just beneath the fracture surface. Depending on the microstructure, damage progressed from the debonded regions along adjacent particles or particle/matrix interfaces.

(b) Enlargement of leftmost crack in (a) for Sample A

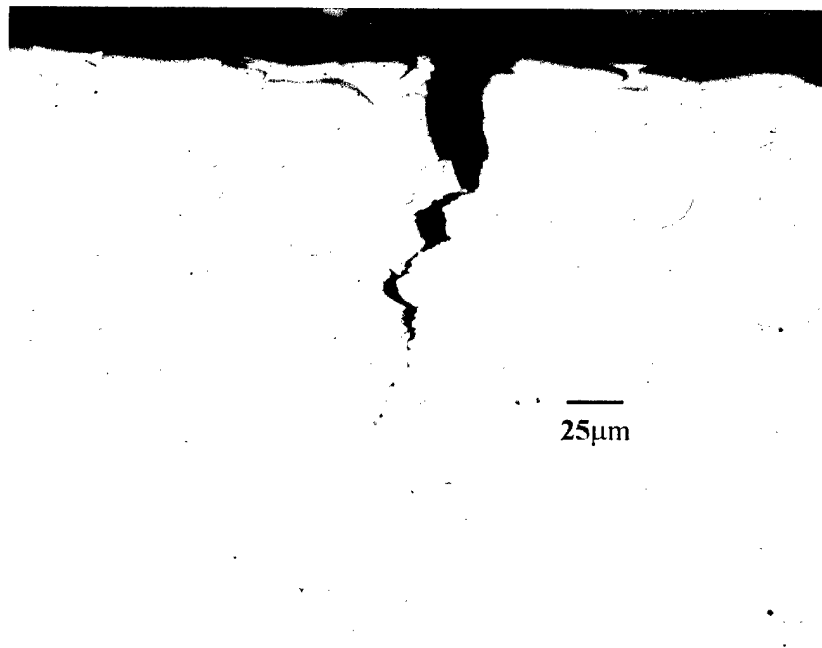
(c) Enlargement of tensile crack for Sample B showing particle fracture

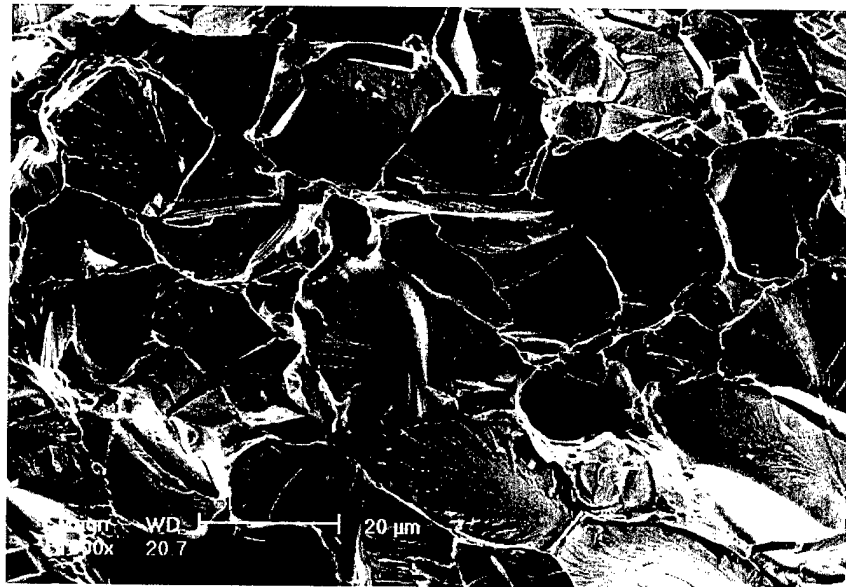
SEM evaluation of the fracture surface confirmed the optical results. Cleavage fracture of the W particles occurred on the tensile side of the fracture, as shown in Fig. 4a. The fracture mode was more ductile towards the central region of the sample. The central region consists of failed intergranular matrix zones, composed of W facets and ductile dimples in the matrix regions. Some cleaved W particles were also detected, along with decohesion between adjacent W particles, and between the W particles and the matrix. Fig. 4b is representative of the central region of the fracture for Sample B. More matrix dimples and W facets were evident in the bend region on the compressive side of the fracture surface. However, W particle cleavage was still observed in the compressive region of the fracture. Compare the compressive region, shown in Fig. 4c, with the other locations on the fracture. Some precipitates are evident in the dimpled matrix regions (Fig. 4d).

(a) Tensile region

Figure 4. SEM micrographs of the fracture surface of Dynamic Bend Sample B.

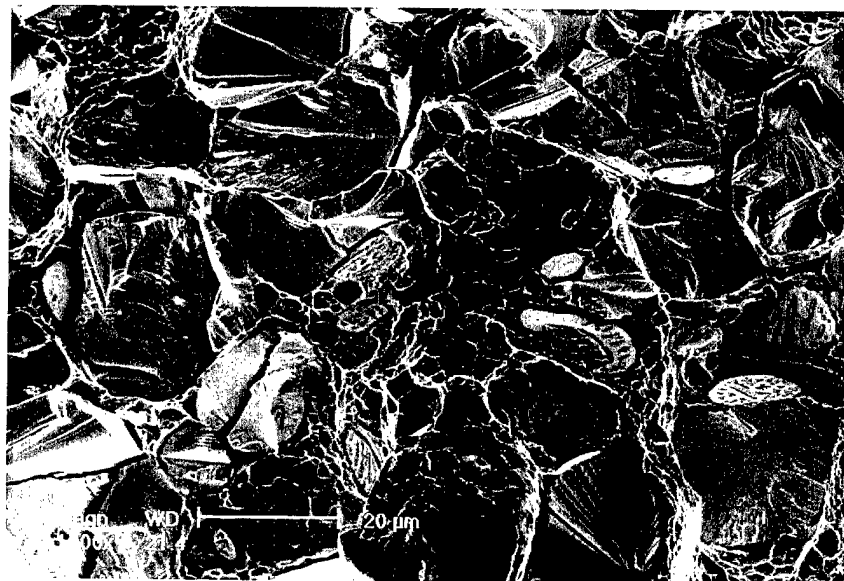
(b) Central region of fracture

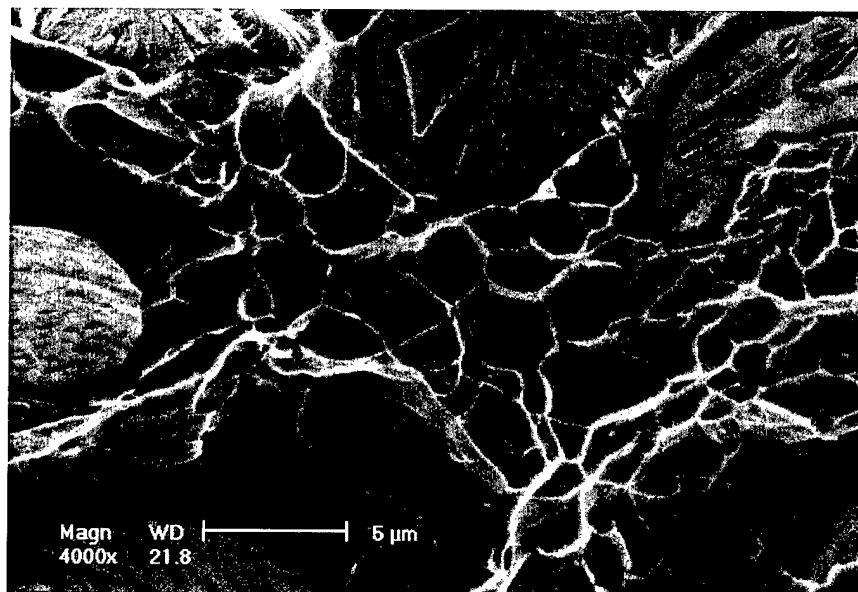
(d) Enlargement of (c)

Figure 4. SEM micrographs of the fracture surface of Dynamic

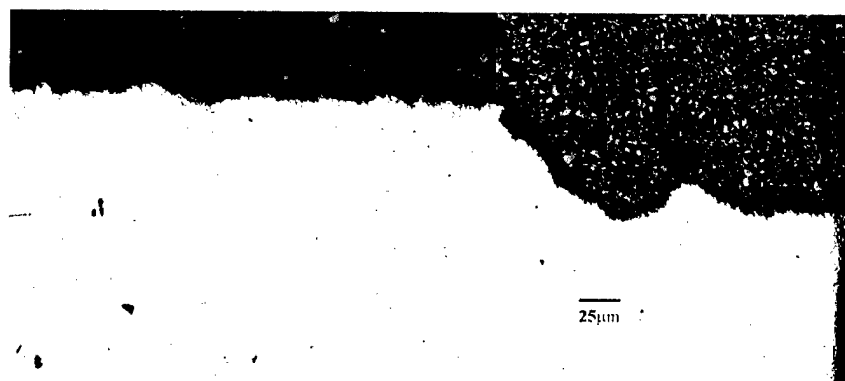
Fractographic and metallographic evaluation of the fractured sample revealed the operation of competitive tensile and compressive fracture modes. The micrograph in Fig. 5b illustrates distinct tensile and compressive regions on the fracture surface. The Al impactor imparted a compressive load. Tensile loading occurred on the surface opposite the impact. Comparison of the microstructures in the tensile and compressive regions of the mounted cross section showed that elongation of the W particles was not as significant for this sample relative to the dynamic bend samples. Maximum strain levels approaching 20 to 40 % were calculated based on particle elongations.

(b) Cross-section through the fracture

Figure 5. Fracture of the WHA rod (Shot 74) following dynamic transverse impact

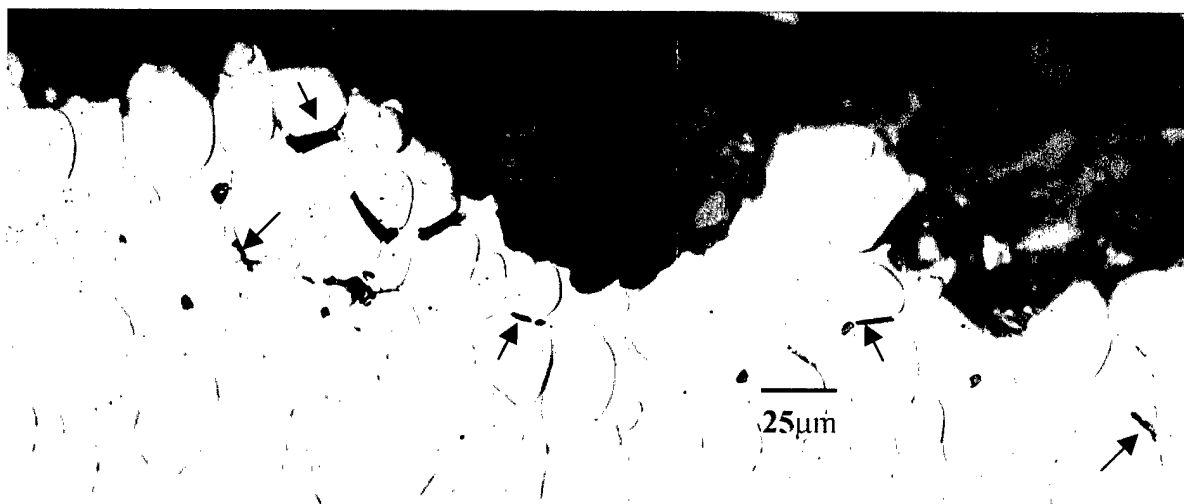
Although a few fractured W particles were observed in the vicinity of the impact region, generally, W particle cleavage was not observed. The W particles remained intact along the fracture surface path as illustrated in Fig. 6. Note the intergranular nature of the fracture path. A limited number of cleaved W particles were evident at the transition region between the tensile and compressive fracture regions. Some W particle fractures were observed on the tensile surface. Although the number of particle fractures observed on the tensile surface was greater for this sample relative to the dynamic bend samples, the fractures only extended through the top two particle surface layers. These had not progressed to form tensile cracks as shown for the dynamic bend test samples in Fig. 2a.

Figure 6. Optical micrograph of a cross section through the fracture surface of Shot 74. Damage development by decohesion between contiguous tungsten particles and between the tungsten particle-matrix interface is highlighted by the arrows.

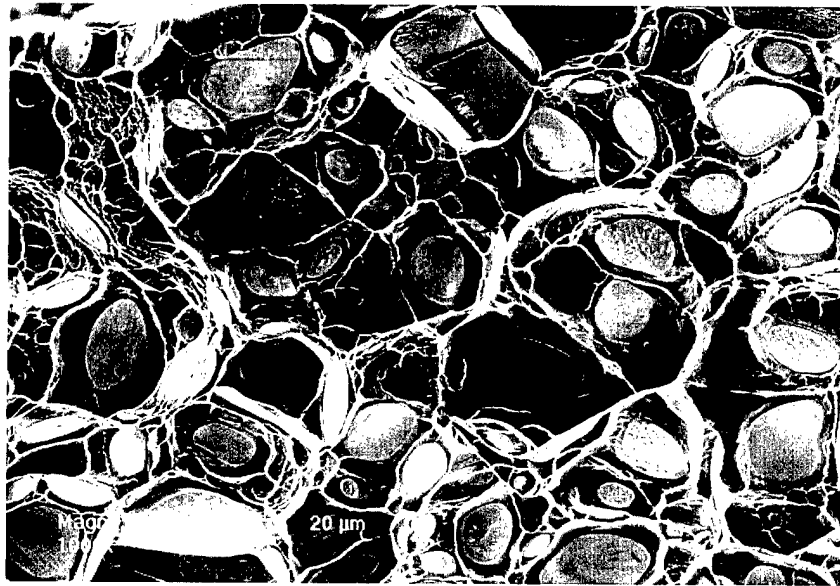
(a) Tensile region

Figure 7. SEM micrographs of the fracture surface region of Shot 74, following dynamic transverse impact.

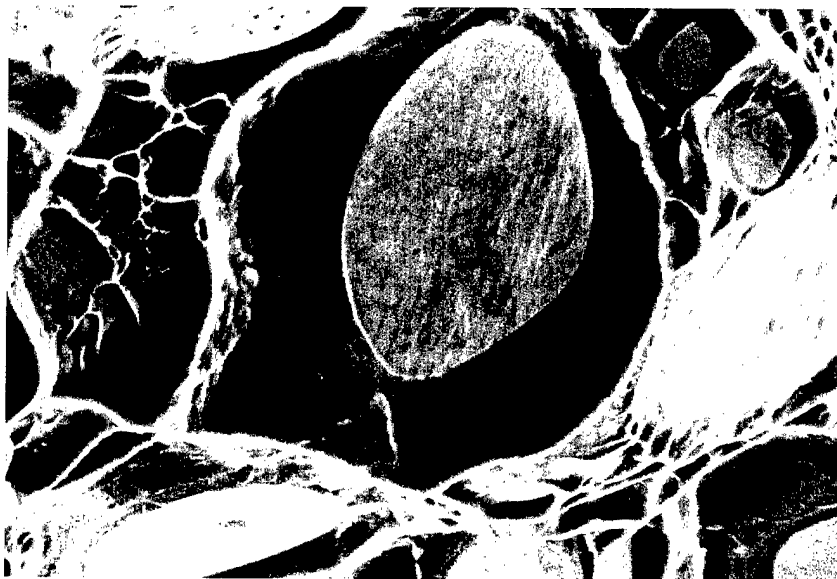
(b) Enlargement of W facet and matrix decohesion

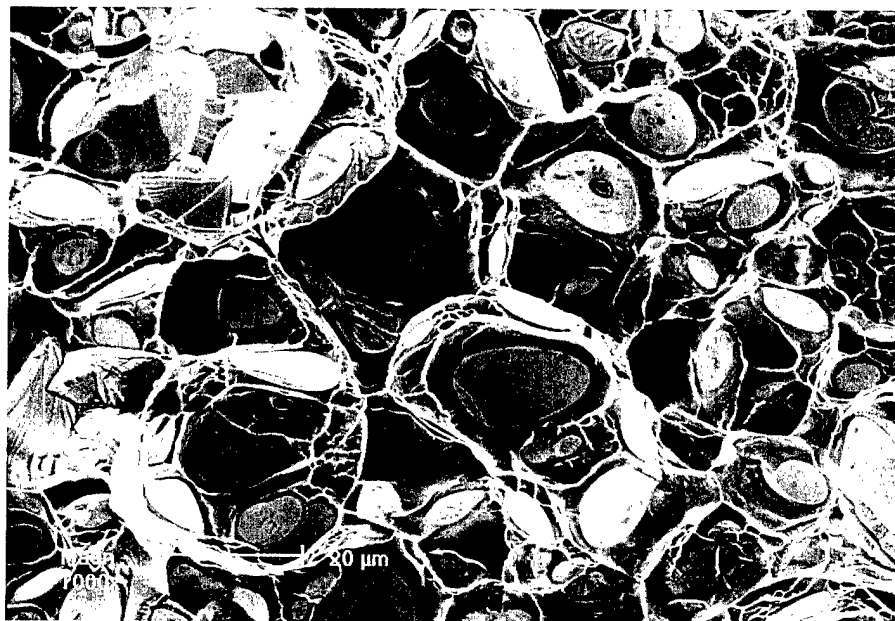
(c) Central region of fracture

Figure 7 SEM micrographs of the fracture surface region of Shot 74, following dynamic transverse impact (continued).

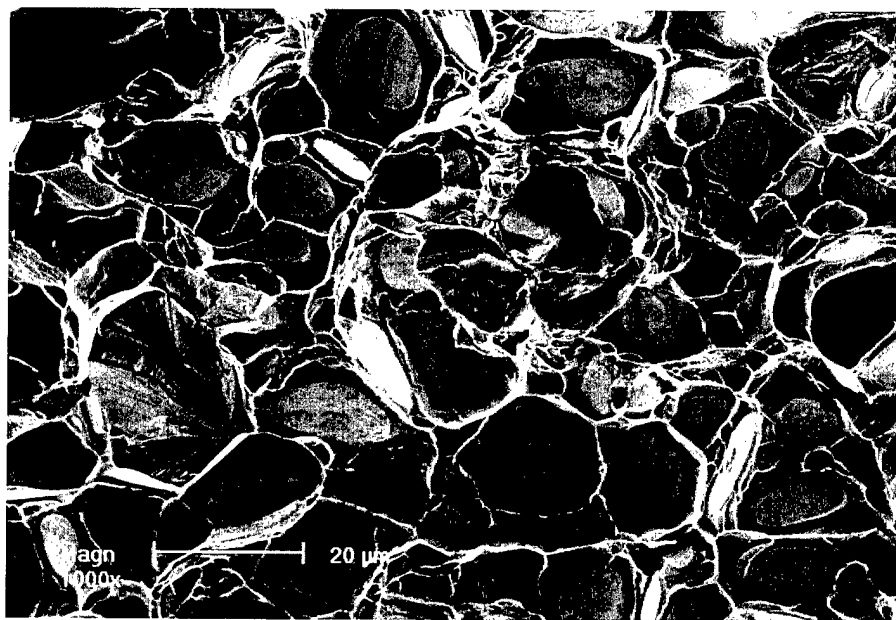
(d) Compressive region

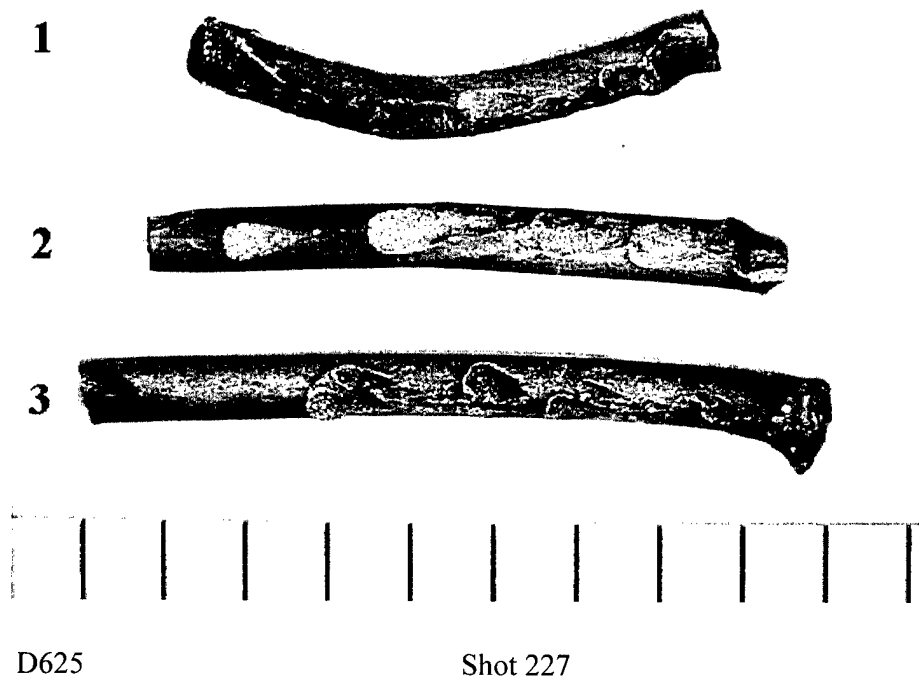
The as-received condition of the remnants from each shot (Shot 225, 226 and 227) is shown in Fig. 8. Impact damage from the target occurred along the surface where the yawed target impacted the W rod. Mushrooming of the impact surface was observed for Shots 226 (Remnant 2, Fig. 8b) and 227 (Remnant 3, Fig. 8c). The extent of mushrooming and surface impact damage is shown in the enlarged view of Shot 227, Fig. 9. The mushrooming phenomenon is characteristic of penetration and is further described for WHA in Ref. [6]. Shear localization occurs after the development of the mushroomed head (i.e., shear localization occurs at a high strain).

Figure 8. Overall view of fragments supplied from each of the reverse ballistic tests (Shot 225, 226 and 227).

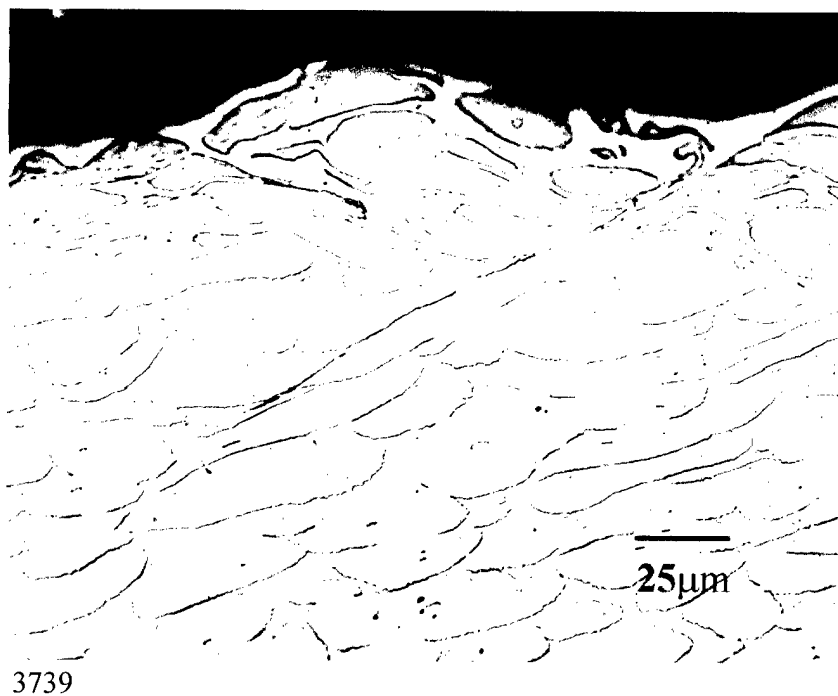
mushroomed ends. The W grains in the mushroomed region were transformed from spherical grains to "pancake"-like grains with extremely high aspect ratios. Elongation of W particles also occurred in the shear band regions. Figure 10 is representative of the shear banding observed, and is consistent with the shear banding reported by Lankford, et al. [3-5] for similar alloys. The extremely high aspect ratio of the W grains within the shear bands indicates that the local shear strains exceeded several hundred percent. Matrix fracture and/or melted matrix areas were detected in some of the shear bands investigated and are further evidence of shear instability.

Figure 10. Elongated particles and matrix fracture in a shear band at the impacted surface of Shot 225 following reverse ballistic testing.

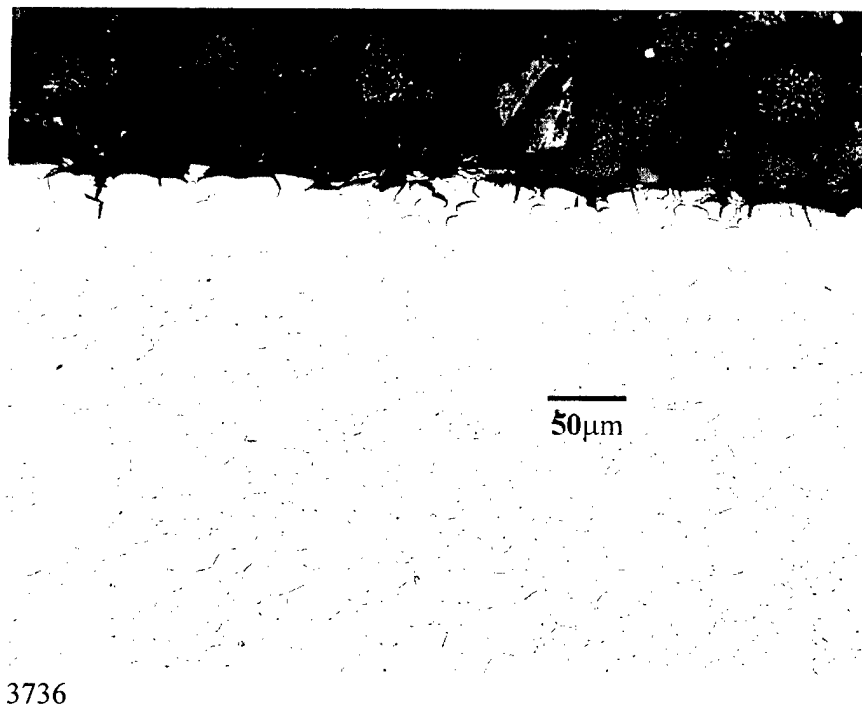
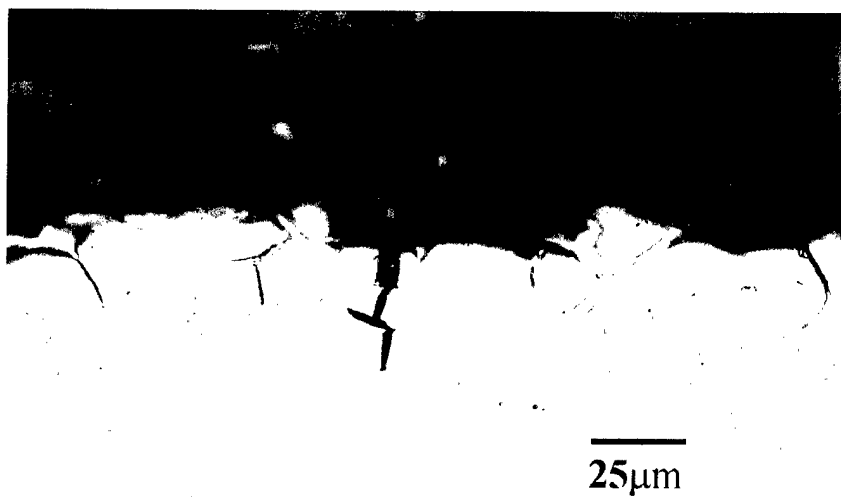
Although shear localization was the predominant form of damage, W particle fracture was observed in some cases on the non-impacted surface (opposite the shear-banded surface) of the remnant. Fracture proceeded through the W particles and appeared to be associated with decohesion of contiguous W particles. Fracture progression through more than three adjacent particles was not detected. The fractured W particles observed at the surface of Shot 227 were concentrated in several regions, and were spaced approximately 30 μm (i.e., a particle spacing) apart. These are illustrated in Fig. 11, taken from the center of the Shot 227 specimen, half-way between two fractured ends (i.e., away from locations where a crack progressed all the way through the rod). These small particle-scale cracks could possibly be examples of widespread initiation sites. However, such fractures are not seen extensively near the fracture surface, and on only one end of the rod are such fractures seen near the actual fracture surface (see Fig. 12). Thus, it is unlikely that many small cracks were uniformly initiated and that the fracture was then dominated by a growth process – i.e., that we should focus on the growth of these small cracks. Rather, understanding initiation is critical.

Figure 11. Low and high magnification views of W particle fractures on the side surface of Shot 227 following reverse ballistic testing. The surface containing the cracks is located opposite the surface containing the shear-banded regions.

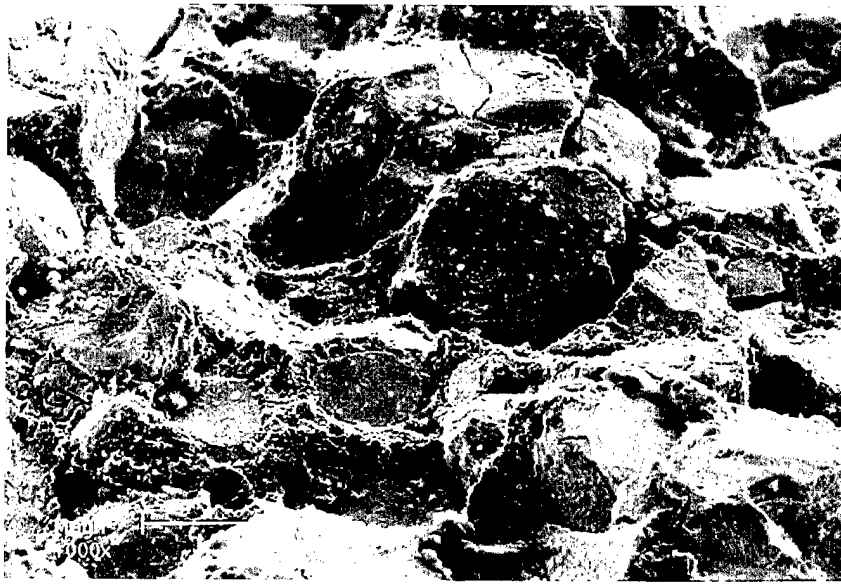
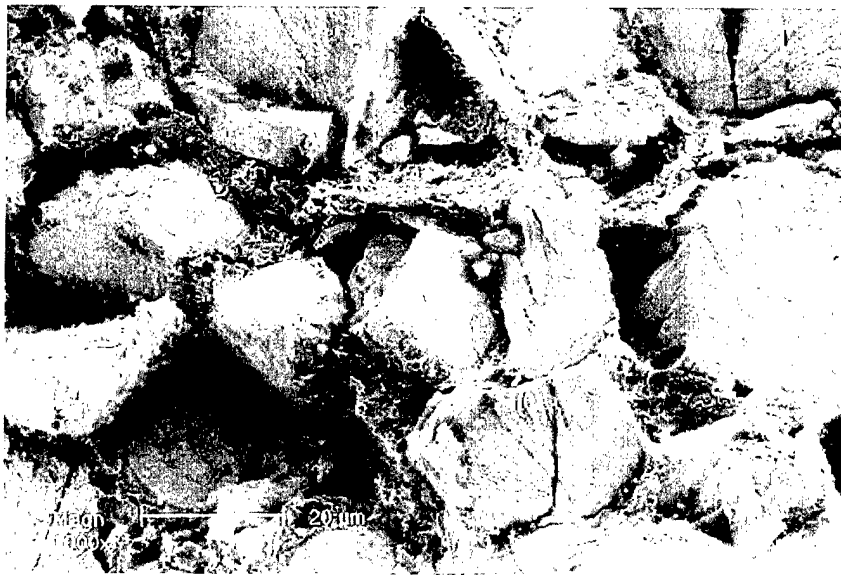
Cleavage of W-particles was more apparent upon SEM evaluation of the "non-mushroomed" fracture surfaces. Evidence of intergranular fracture was observed. Dimpled matrix regions were not as prevalent as for the dynamic bend test samples already discussed (*Dynamic Bend* section) for this alloy. Decohesion of W particles from the matrix was detected in isolated locations. Cleavage of numerous W particles was observed parallel to the rod axis. Representative photos of these features are illustrated in Fig. 14. The fracture mode is more brittle than the other test samples evaluated owing to the high loading rate and yawed projectile.

Figure 14. SEM micrographs of the fracture surface of Shot 227 showing W particle-matrix decohesion, cleaved and faceted W particles.
